Manhole Inspection Summary

Manhole # S05AA2018MH

Insp Date: **9/20/06 3:40 PM**

Location Address: **5971 WESTERN RUN DR** Cross Street: **BAYWOOD AVE**

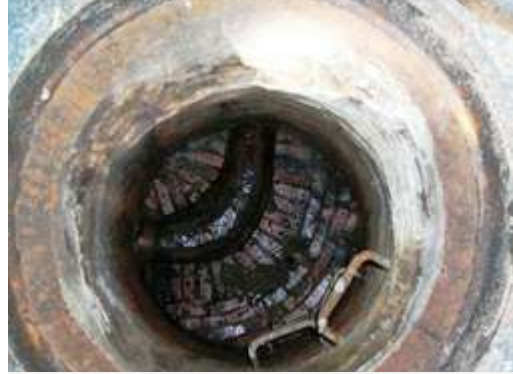
Top View

Bench ☒ Exists Material: **Brick** ☐ Parged ☒ **Debris** (not Condition related)
Condition: ☒ Sound ☐ Cracked ☐ Root Intrusion ☐ Deteriorated ☐ Leaks ☐ Debris

Steps Count: **4** Missing: **0** ☒ **Corroded**

Surcharge ☒ **Evidence Of Surcharge** Depth: **1** (ft.) ☐ Active Surcharge Present

Evidence of surcharge - Bench debris.
Corroded steps.

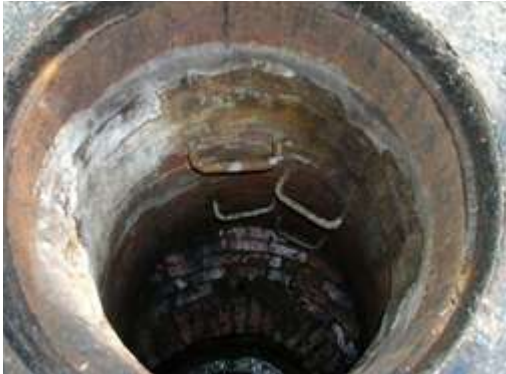
Defect

Chimney / Frame Adjustment ☒ Exists Material: **Brick** ☒ Parged Height: **7** (in.)
Condition: ☐ Sound ☐ Cracked ☐ Root Intrusion ☐ Loose Brick ☒ **Deteriorated**
Infiltration: ☐ None ☒ **Joint** ☐ Cracks ☒ **Mortar** ☐ Roots ☐ Wall

Corbel Material: **Brick** ☐ Parged Type: **Concentric/Eccentric**
Condition: ☒ Sound ☐ Cracked ☐ Root Intrusion ☐ Loose Brick ☐ Deteriorated
Infiltration: ☐ None ☐ Joint ☐ Cracks ☒ **Mortar** ☐ Roots ☒ **Wall**

Barrel Material: **Brick** ☐ Parged
Shape: **Circular** Diameter: **48** (in.) Length: (in.)
Condition: ☒ Sound ☐ Cracked ☐ Root Intrusion ☐ Loose Brick ☐ Deteriorated
Infiltration: ☐ None ☐ Joint ☐ Cracks ☒ **Mortar** ☐ Roots ☒ **Wall**

Adjustment deterioration. Adjustment,
Corbel, and Barrel infiltration - other side.

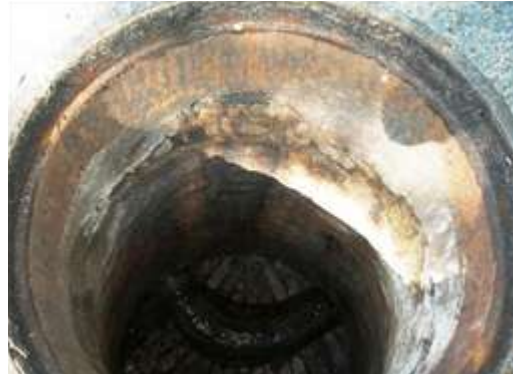
Defect

Adjustment deterioration. Adjustment,
Corbel, and Barrel infiltration.

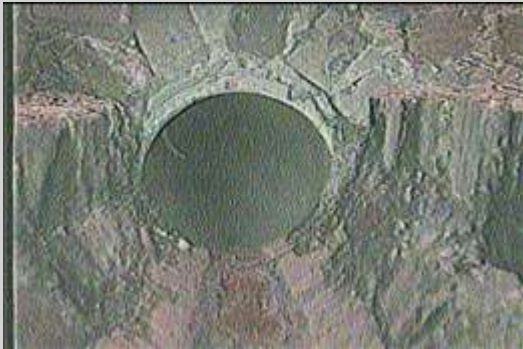
8 in. Circular Gravity Sewer Pipe Out @ 12 O'Clock

Comments **The O12 pipe picture shows Channel deterioration and leaks.**

Channel Material: **Brick** ☐ Parged ☐ Debris (not Condition related)
Channel Exposure: **Fully Open** Junc Dist: **0** nearest .5 ft. Azimuth:
Condition: ☐ Sound ☐ Cracked ☐ Root Intrusion ☒ **Deteriorated** ☒ **Leaks** ☐ Debris

Infiltration: **Evidence** Pipe Seal Cond: **Unknown**

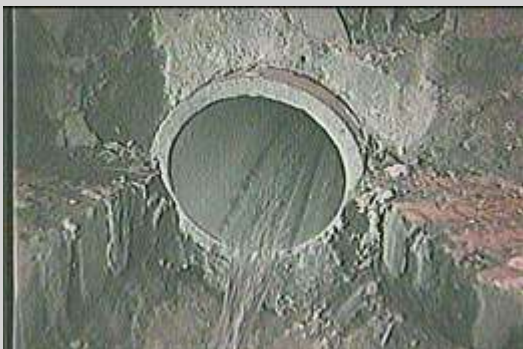
8 in. Circular Gravity Sewer Pipe In @ 9 O'Clock

Infiltration: **Evidence** Pipe Seal Cond: **Unknown**
